REPORT OF INVESTIGATION
(UNDERGROUND COAL MINE)

MULTIPLE FATAL ROOF FALL ACCIDENT (BUMP)

Braztah No. 3 Mine (ID No. 42-00165)
Braztah Corporation
Helper, Carbon County, Utah

April 27, 1978

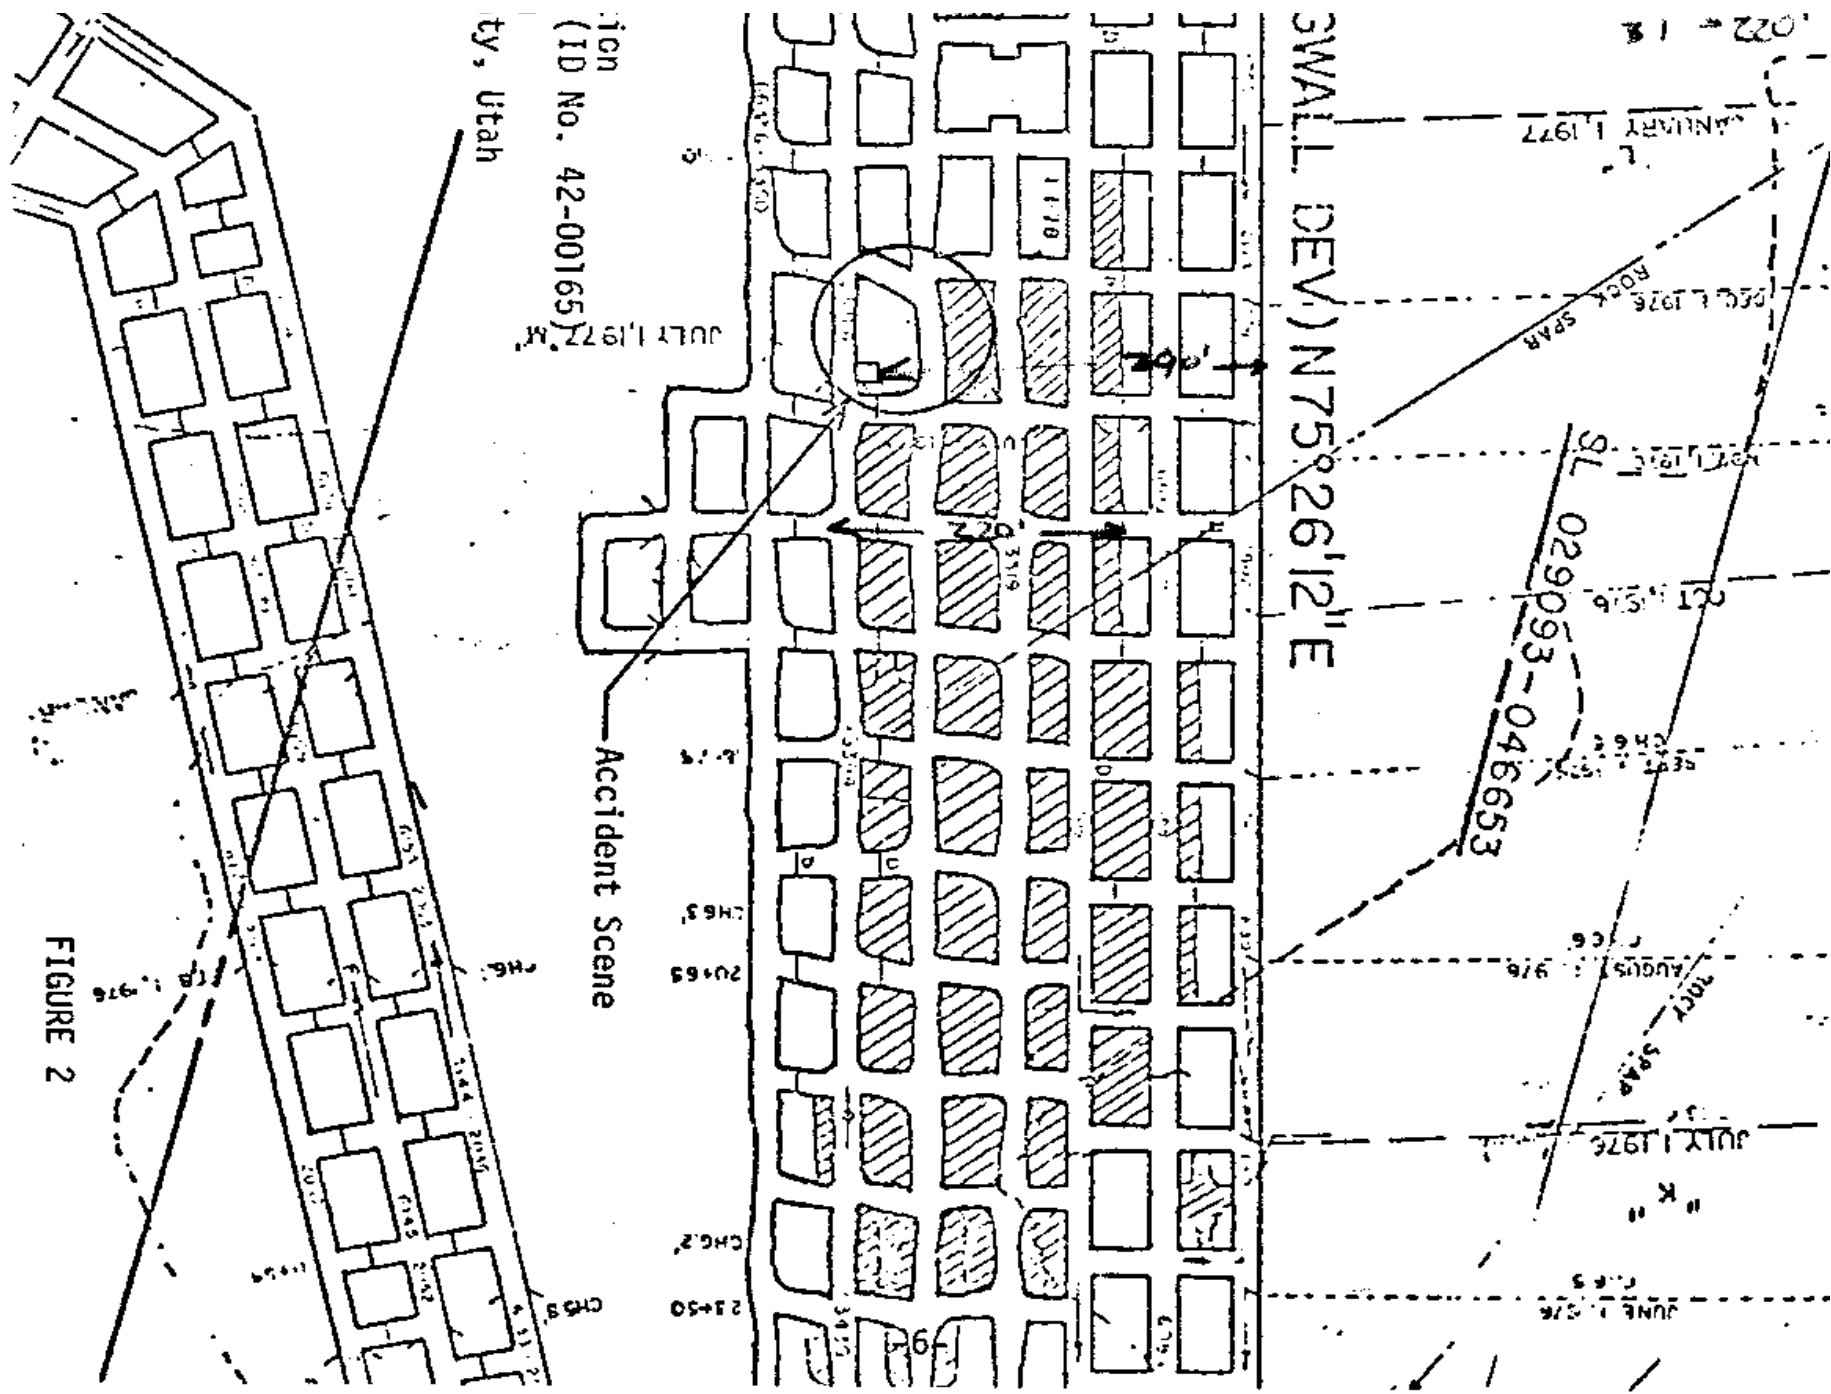
9. In general, entries were established on 65-foot centers with connecting crosscuts at 105-foot intervals
10. The pillar involved in the accident, prior to second mining, was irregular in shape in that the No. 9 crosscut was developed at a north-easterly angle reducing the length of the down dip (cave) side (see Figure 2).

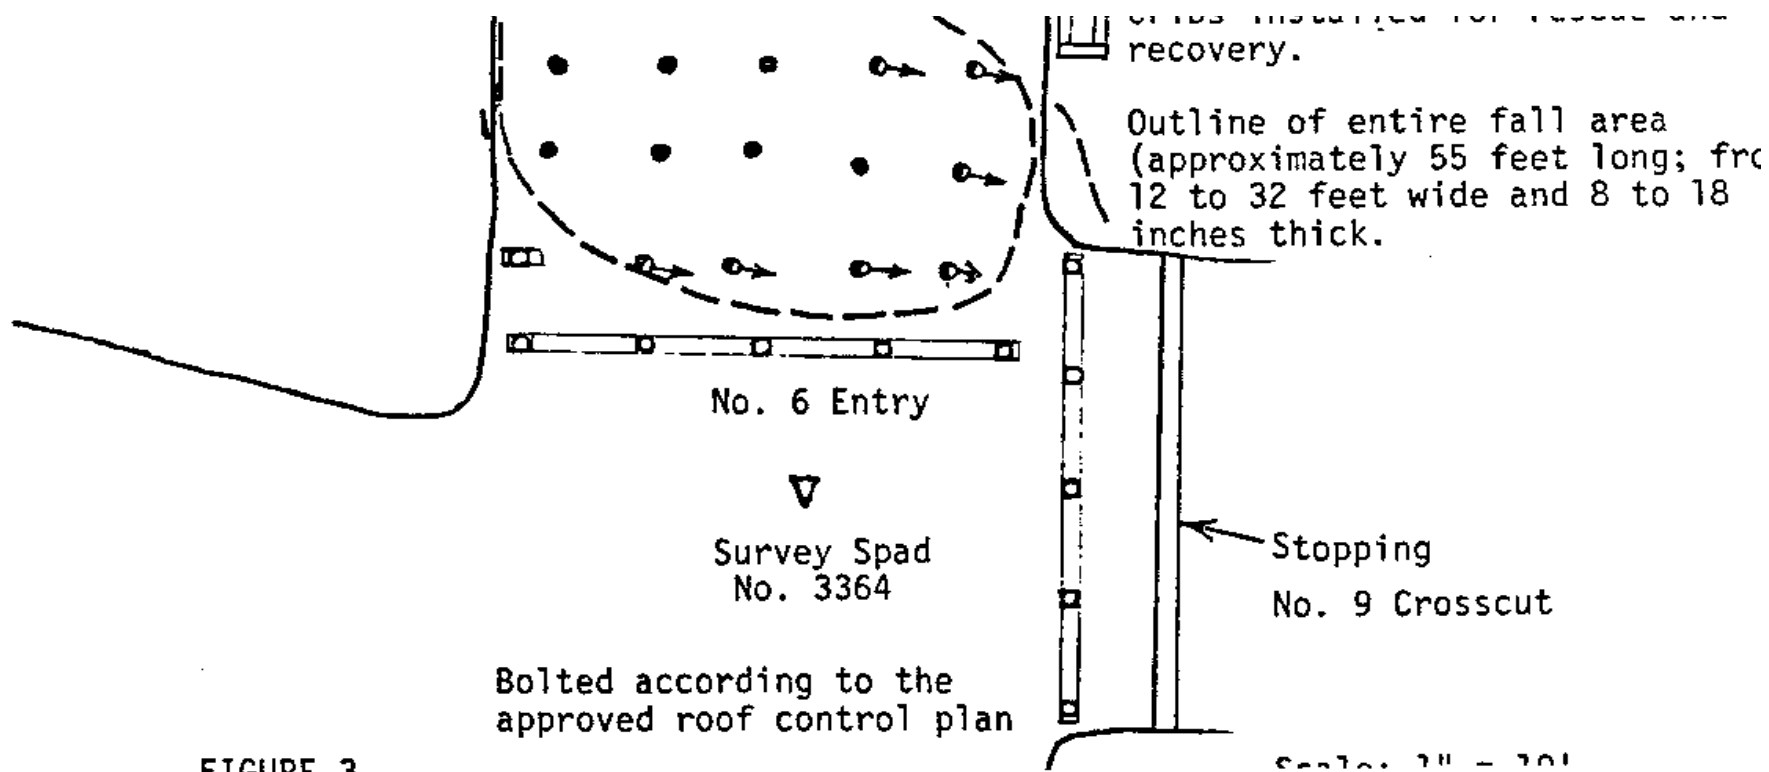
1. A mine bump or bumps caused 36 roof bolts to be sheared off at the fall horizon and 10 additional bolts were sheared, each protruding 2 to 12 inches from the fall horizon, showing a lateral movement of the roof (see Figure 3).

The accident occurred because a mine bump caused severe lateral movement of the immediate roof, resulting in the shearing off of 46 resin type roof bolts which caused the immediate roof to fall.
